Home Inspection Report

XXXX, ####, Auckland

Date of Inspection: 3/8/2018

Age of Home: 1940's Size: 159m²

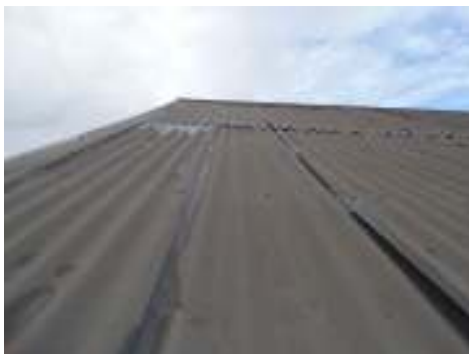
Slight sagging seen at the time of inspection. Extra support would be beneficial.

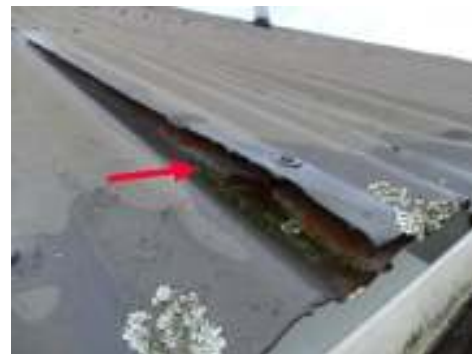
3. Lapping

Minor lifting - Repairs/maintenance recommended to ensure weather tightness.

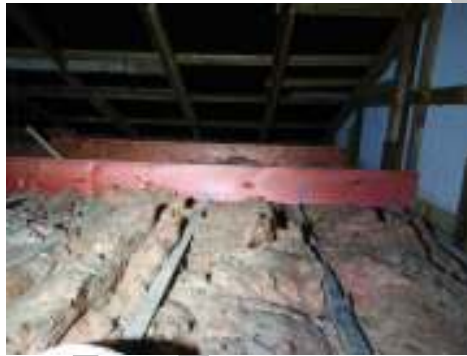
3. Obvious structural alteration

A number of areas were noted to have had structural support added.

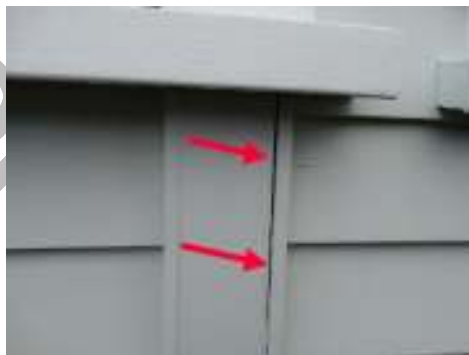
5. Splitting and rot

Minor cracking visible at the time of inspection. Recommend maintenance on any cracks around the house.

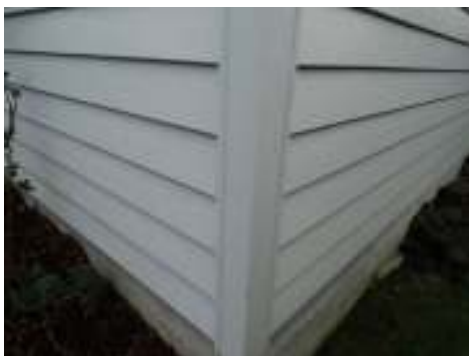
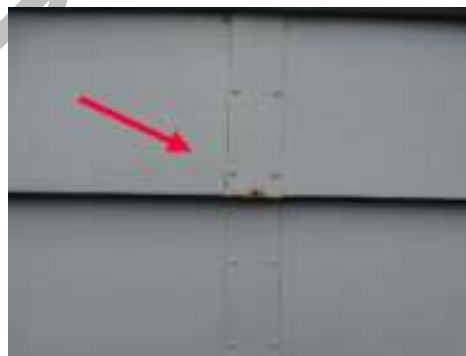
Minor corrosion noted.

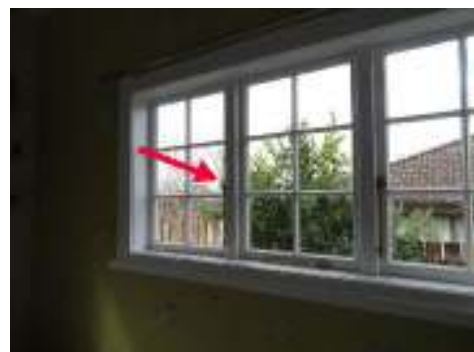
3. Operation and fit

A M D NP NI
X A few windows around the house felt jammed. Timber does swell in colder months and these windows may just need forced a little.

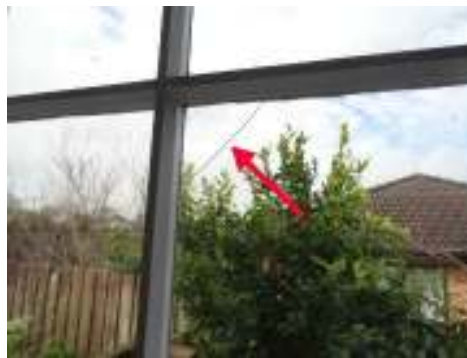
3rd Bedroom.

One window pane in the bedroom has a cracked glass.

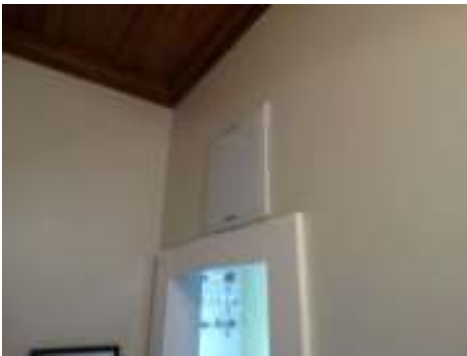
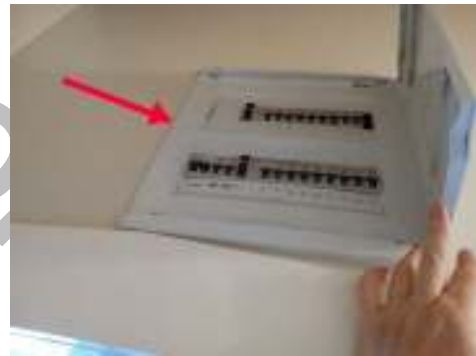
Door fell off when opened.

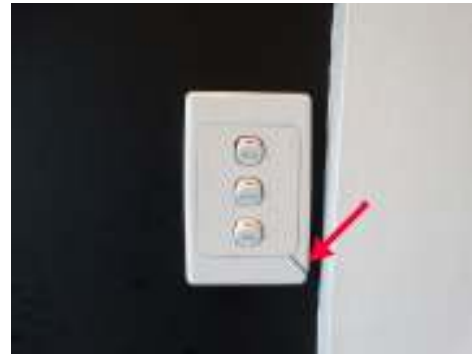
Cracked switch.

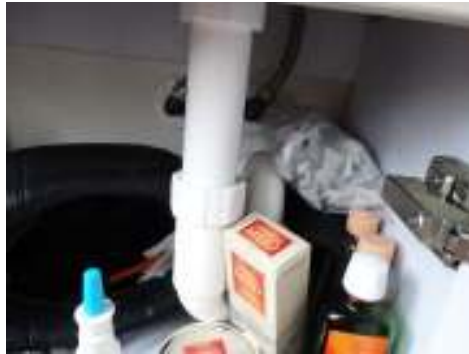
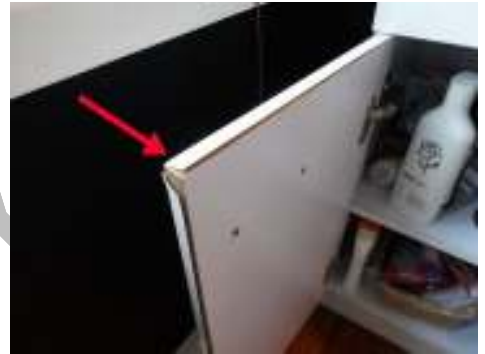
Door cover delaminating.

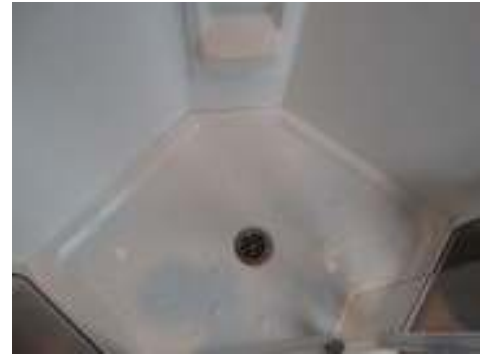
No seal present.

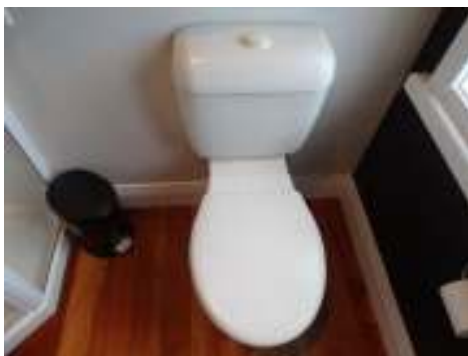
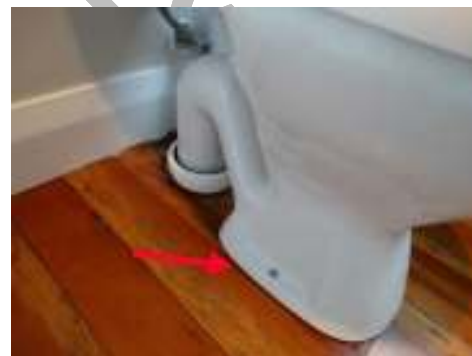
Sealant would be beneficial.

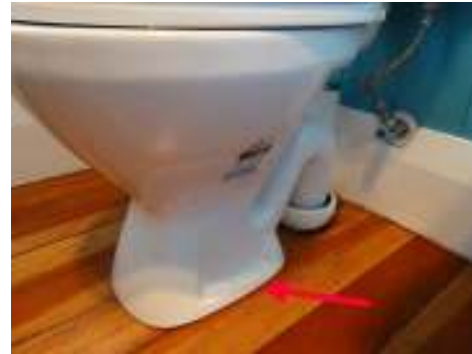
Sealant would be beneficial.
