Home Inspection Report

XXXX, ####, Auckland

Date of Inspection: 3/8/2018

Age of Home: 1940's Size: 159m²

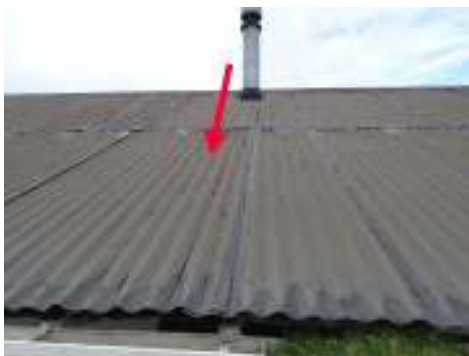
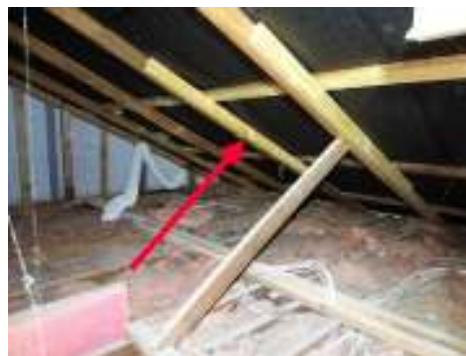
3. Sagging

Slight sagging seen at the time of inspection. Extra support would be beneficial.

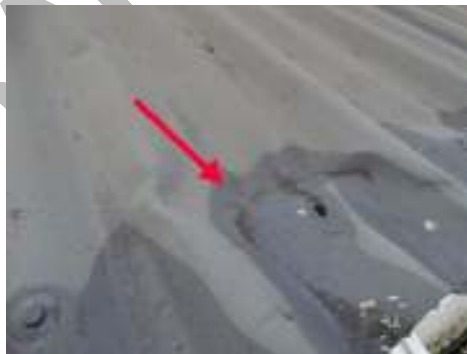
2. Damage to ribs

Yes some crushes areas noted.

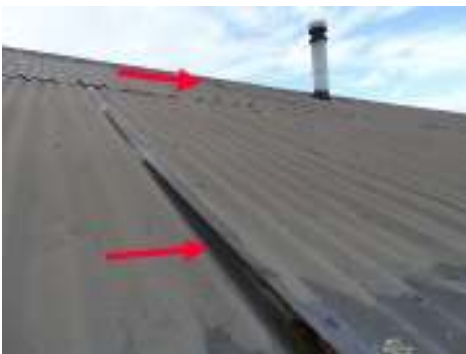
3. Lapping

Minor lifting - Repairs/maintenance recommended to ensure weather tightness.

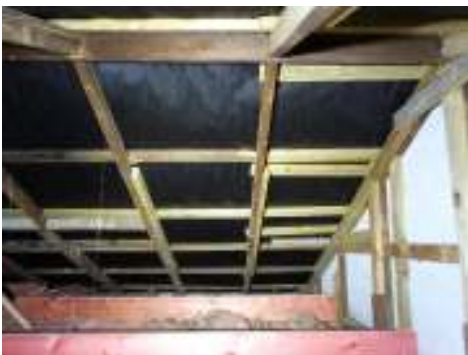
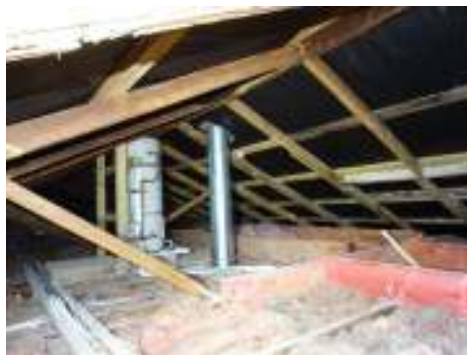
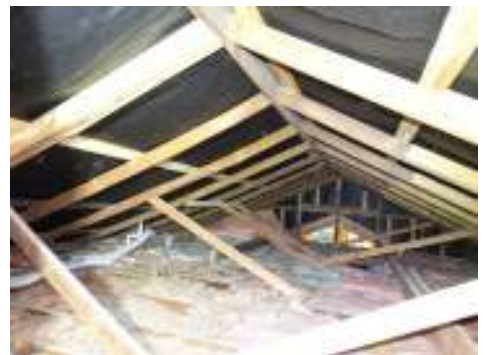
2. Roof Space Assessment

- Sarking is present covering the underside of this roof covering. Sarking is a vapour barrier to reduce the transmission of moisture into the home.
- No signs of excess moisture was visibly showing in the roof space.
- The roof framing looks acceptable in nature though added support would be beneficial.
- No evidence of pest or insect infestation.
- No rot evident at the time of inspection.
- Discharges from wet areas like bathrooms, laundrys and kitchens etc should not vent into the roof space due to the high level of moisture that can be produced. No visible discharges.

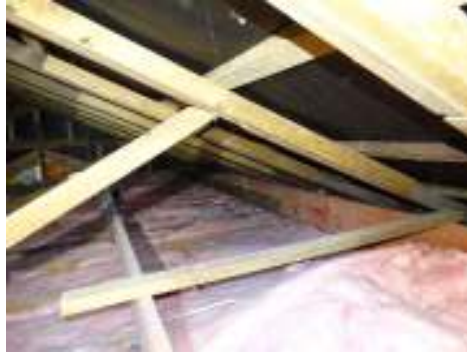
3. Obvious structural alteration

A number of areas were noted to have had structural support added.

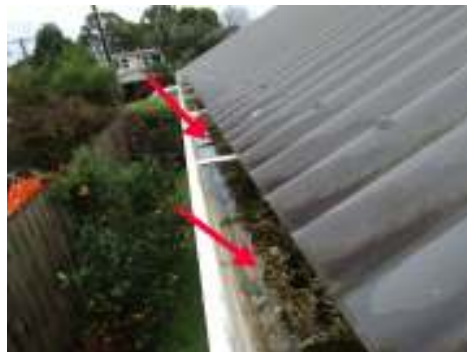
3. Fall

There is still water sitting in the spouting around this home, the spouting should be cleared of any debris and then checked to see the angle of slope is great enough so as water drains away towards there down pipes.

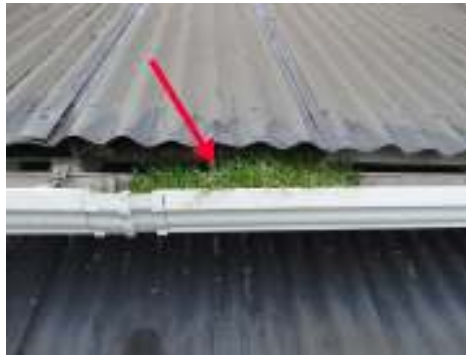
4. Obstruction

NI There is a small amount of debris build up within the spouting, while it is not currently a major obstruction there are benefits to having it cleared.

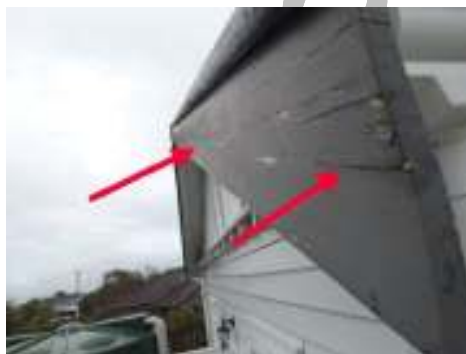
2. Deterioration

NI Minor deterioration noted, repairs/maintenance advised.

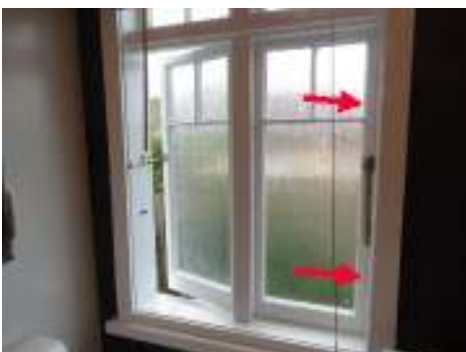
3. Operation and fit

A M D NP NI
X A few windows around the house felt jammed. Timber does swell in colder months and these windows may just need forced a little.

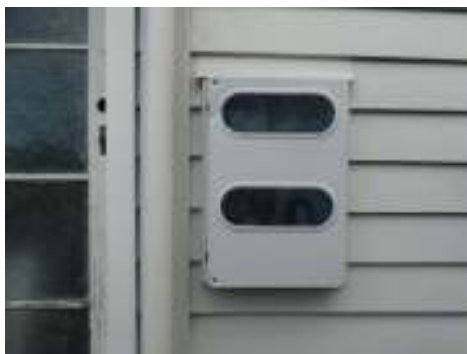
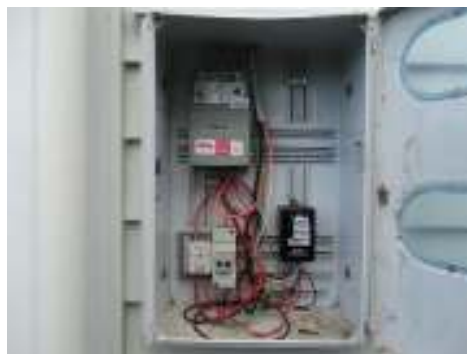
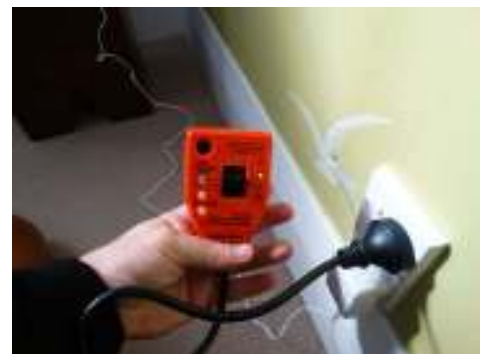
- Electricity enters the house by means of underground lines.
- The meter box is located on the rear wall of the home.
- The meter box looks to be in good condition.
- The earth registered as connected when tested from within the dwelling.

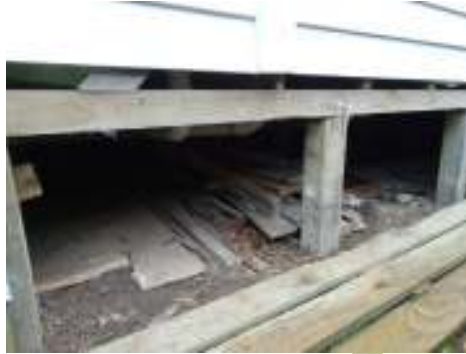
1. Access Point

Rear of property.

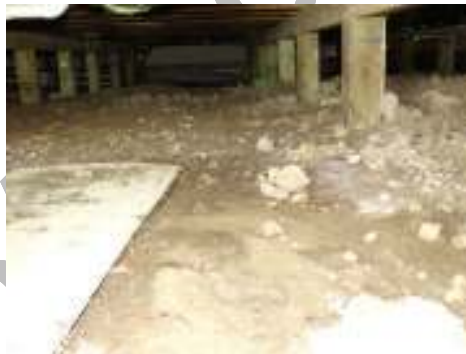
2. Ground Condition

Damp at the time of the inspection.

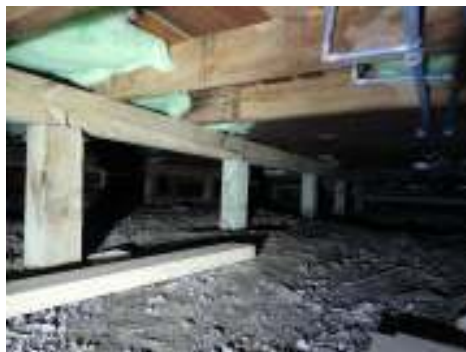
1. Foundation type

Timber piles.

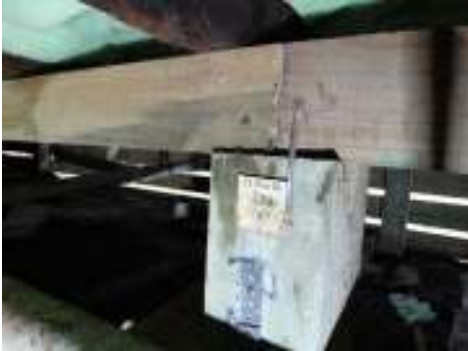
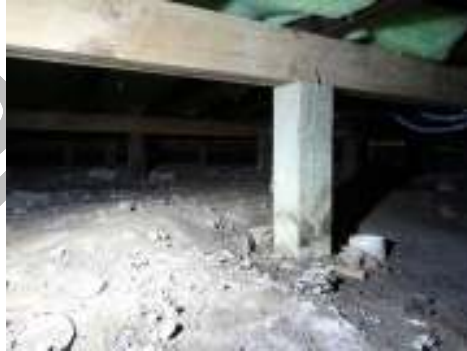
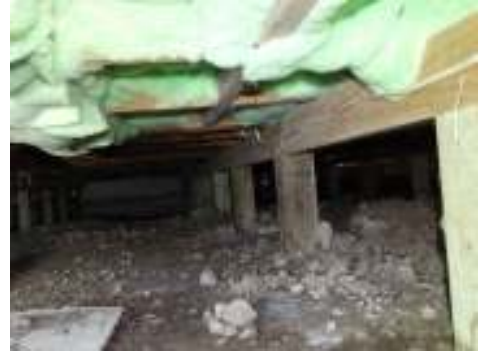
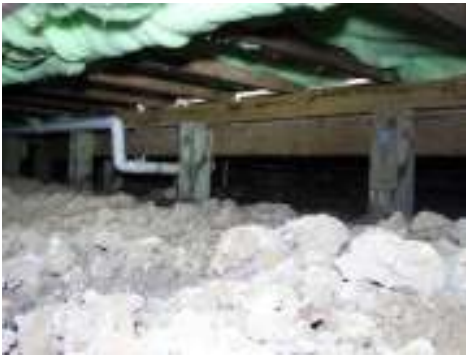
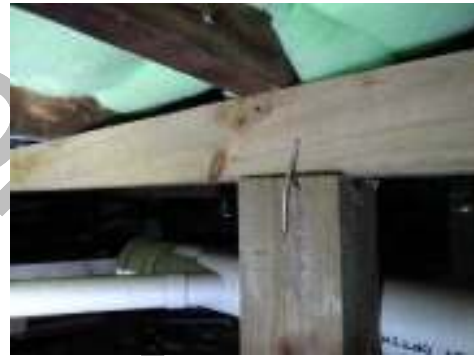
2. Foundations Condition

- Piles appeared stable at the time of the inspection.
- The bearers are visibly in a satisfactory condition.
- The floor joists look to be in a satisfactory condition.
- Bracing is acceptable in nature.
- No visible rotten timber noted.
- Ground clearance from timber framing is satisfactory.

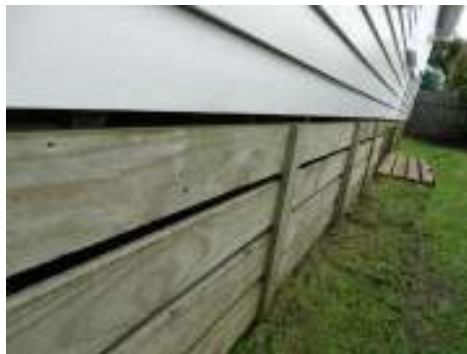
3. Foundation walls

Wooden slats.

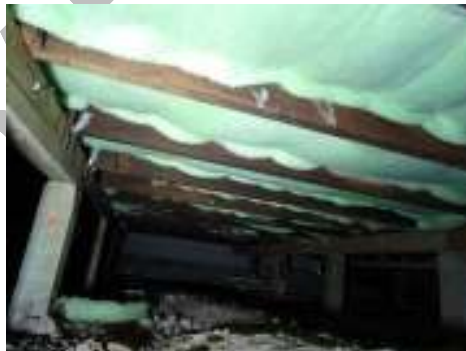
2. Coverage

Adequate coverage.

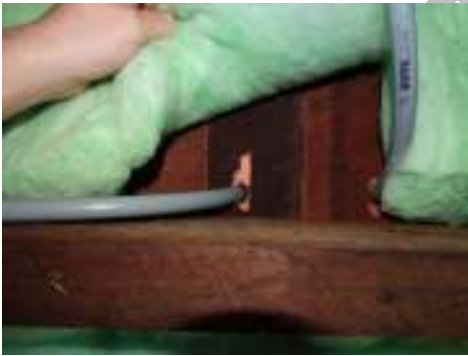
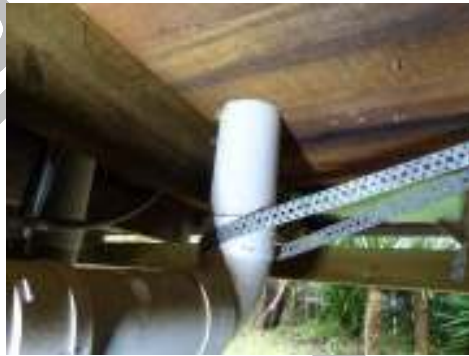
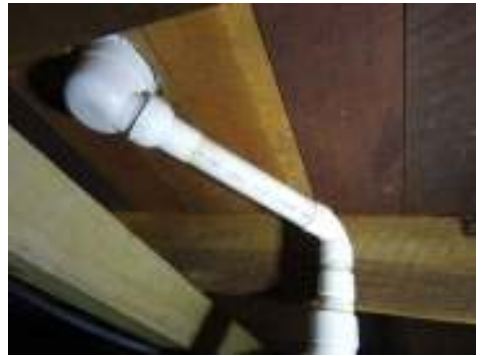
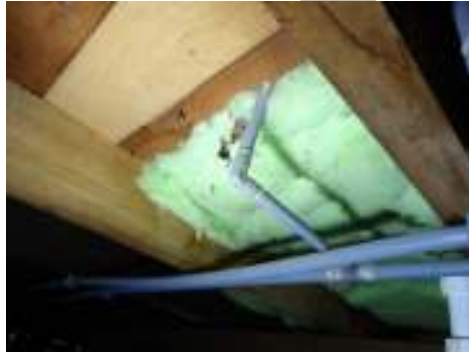
2. Leakage

No visible signs of leakage at the time of the inspection.

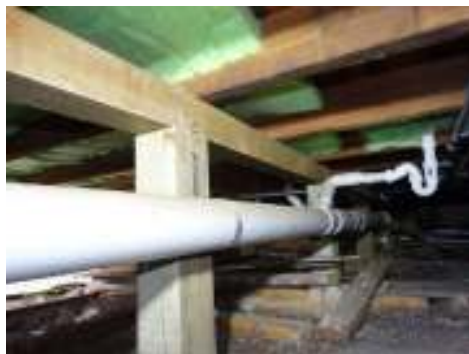
3. Support

Pipes are well supported.

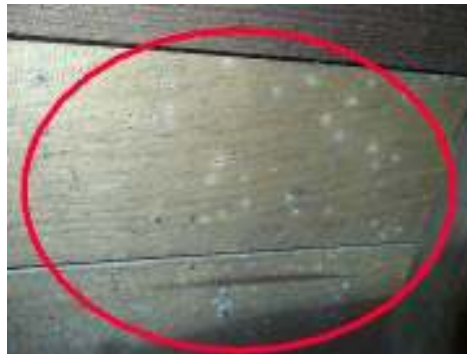
1. Insect and pest infestation

Page 22 Item: 1	Insect and pest infestation	Some evidence of borer. Treatment recommended.
-----------------	-----------------------------	--

Some evidence of borer. Treatment recommended.

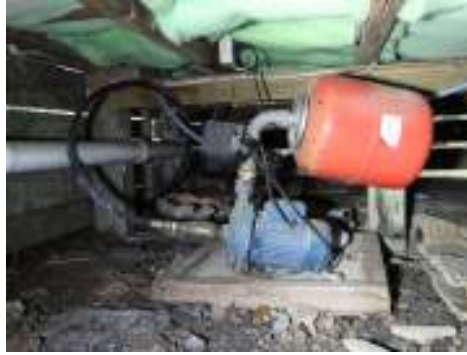
Found in the crawl space under the home.

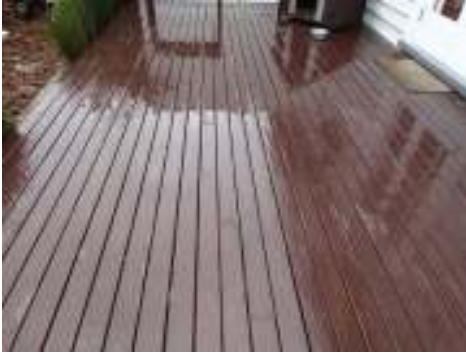
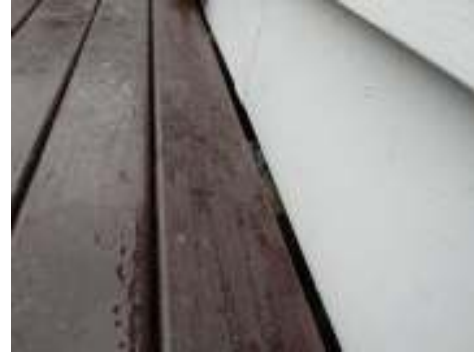
2. Deck Assessment

- The deck is of timber construction.
- The floor material is in a satisfactory condition.
- There was no excessive springiness felt in the deck at the time of inspection.
- Clearance between the cladding and the deck are acceptable.

Please note due to the lack of access under the deck the substructure could not be viewed.

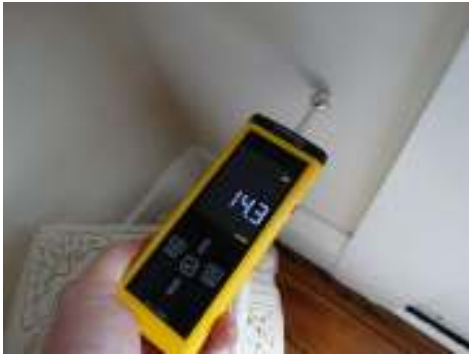
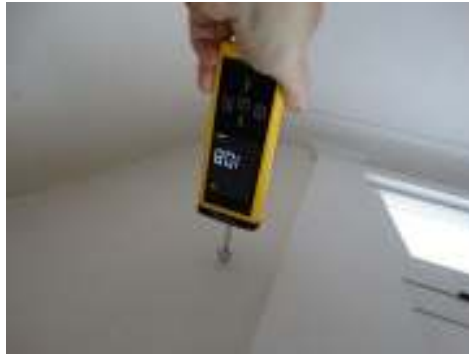
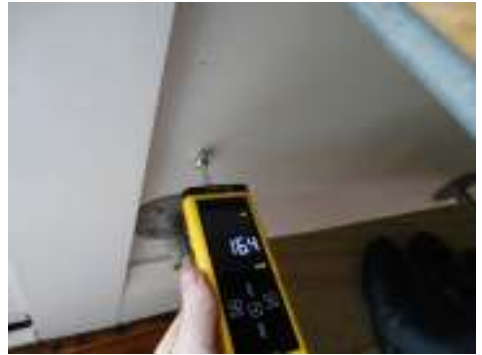
3. Moisture Readings

The moisture levels in this area were of an acceptable level for this type of home.

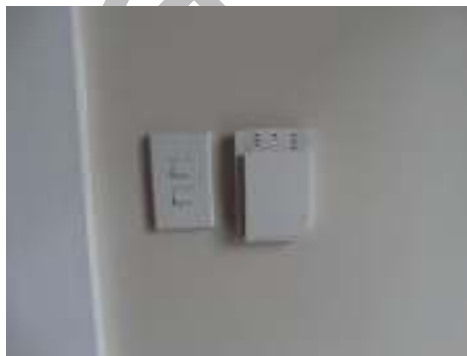
1. Burglar Alarm System

Sensors, exterior alarm, internal alarm siren and key pads were present, however the system was not tested as part of this inspection.

We recommend you find out the contact details for the installation company and change the alarm codes.

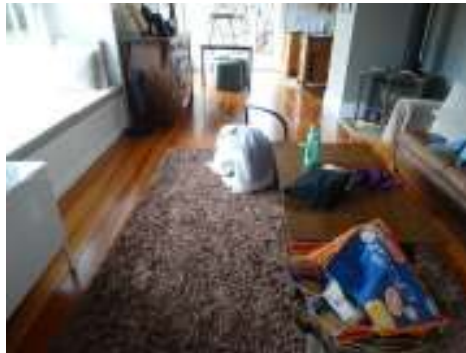
2. Room Assessment

- The lights & switches and any accessible power sockets were functional.
- Over all the walls & coverings were visually in good condition.
- The ceiling is in a satisfactory condition.
- The flooring is in an acceptable condition.

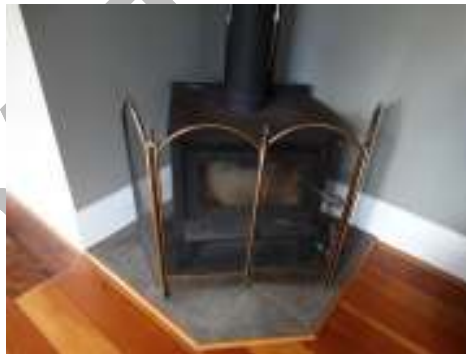
3. Fixed heating

Fireplace.
Functional.

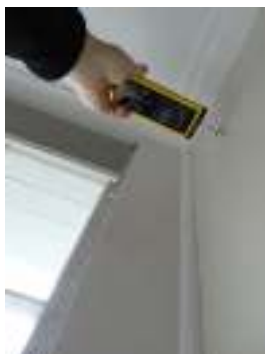
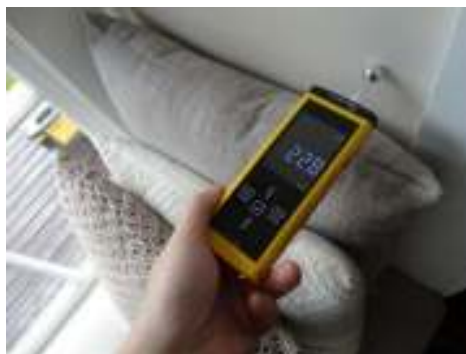
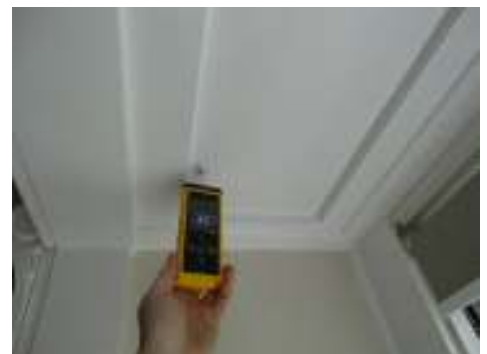
4. Moisture Readings

A number of moisture readings were taken within this room all found to be of an acceptable level.

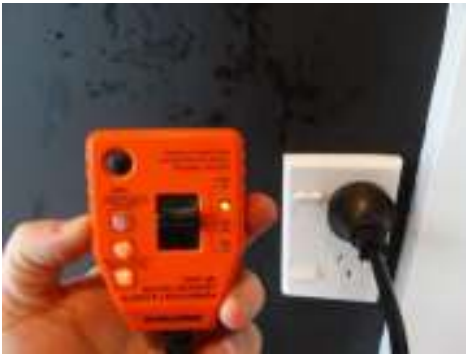
Cracked switch.

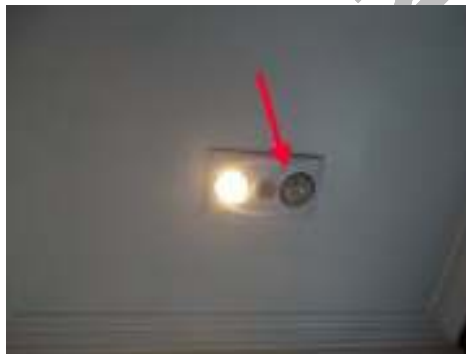
Functional though fan was noted to be noisy and heat lamp bulb has blown.

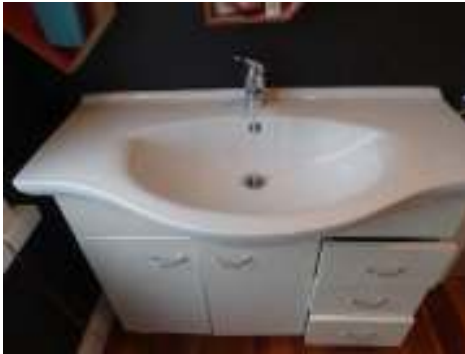
Door cover delaminating.

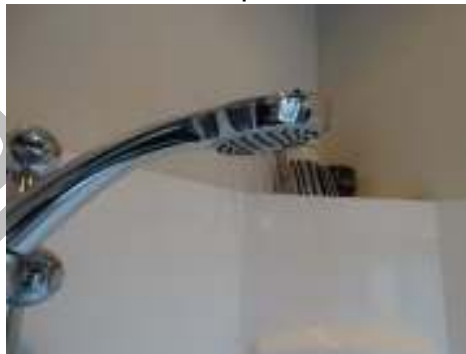
No seal present.

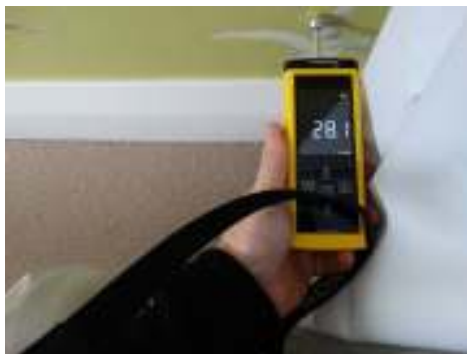
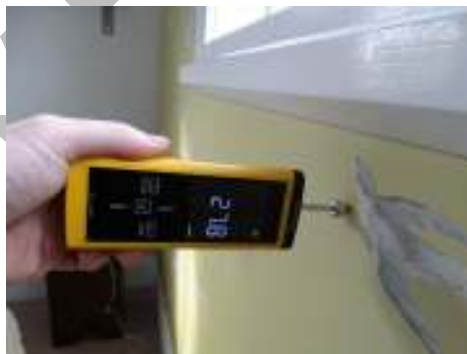
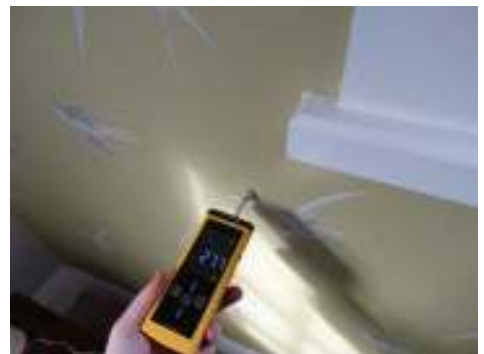
X The moisture readings taken around the walls were of an acceptable level for this type of home.

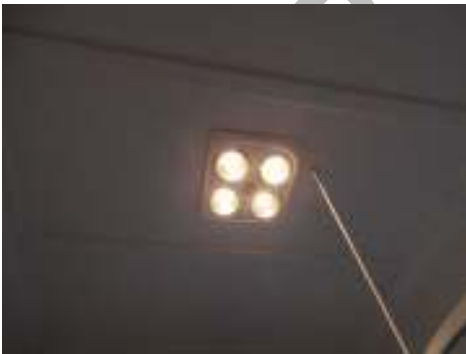
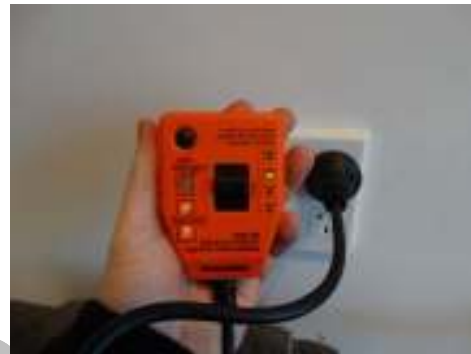
- The doors and frames in this room are operational & in an acceptable condition.
- The lights & switches were functional.
- Over all the walls & coverings were visually in good condition.
- The ceiling is in a satisfactory condition.
- The flooring is in an acceptable condition.
- An air extraction fan is present and functional at the time of this inspection.
- Accessible power sockets were functional.

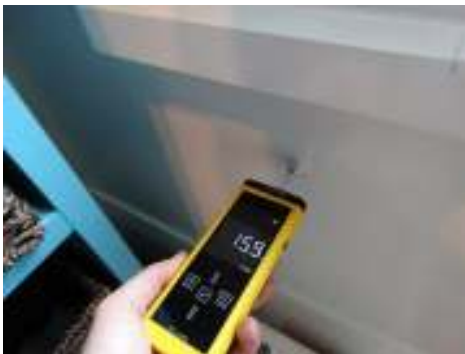
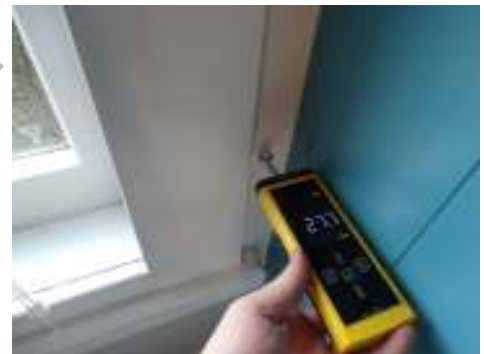
The moisture levels in this area were of an acceptable level for this type of home.

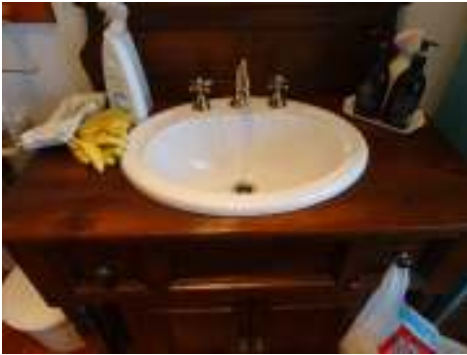
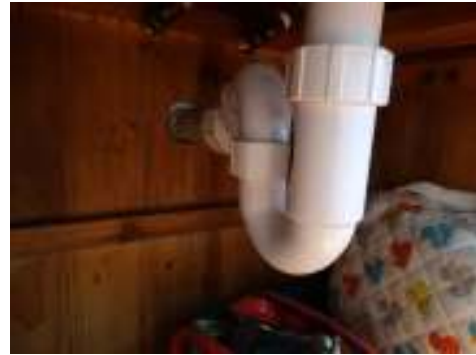
- The vanity top & basin is in an acceptable condition.
- There was no sign of leakage from the taps or waste traps.
- The vanity top & basin is sufficiently sealed at the wall junction.
- The vanities doors and draws hardware operated as they should.

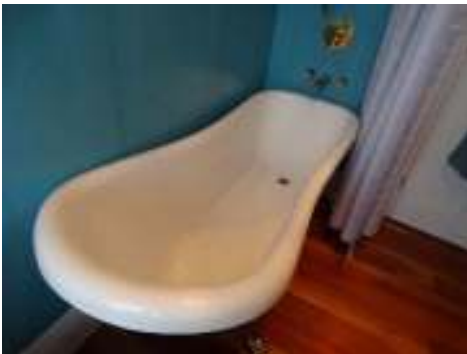
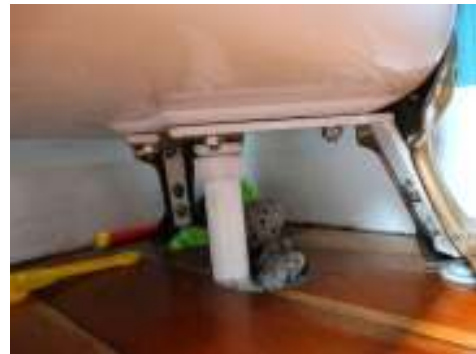
- The bath tub looks to be in an acceptable condition.
- No visible signs of leakage from the taps.
- The wall lining around the bath is in good condition.

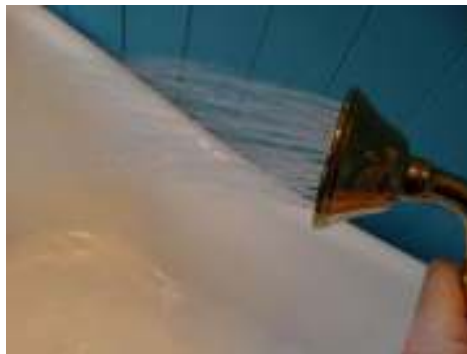
- The shower curtain & rail look to be in a satisfactory condition.
- No leaks were seen from the taps.
- An adequate pressure flow was noted.
- The shower is over the bath.

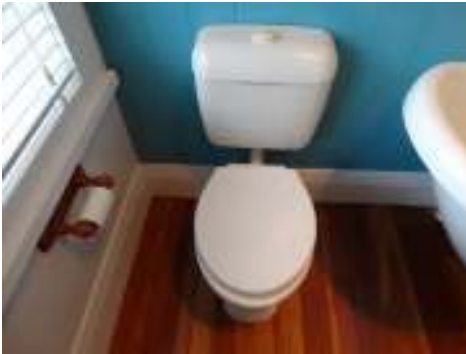
- The flush operated as it should.
- The plumbing was functional with no visible signs of leakage.

Sealant would be beneficial.

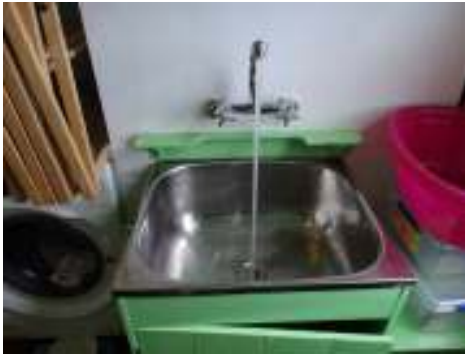
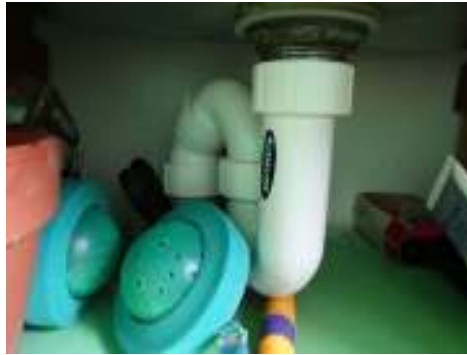
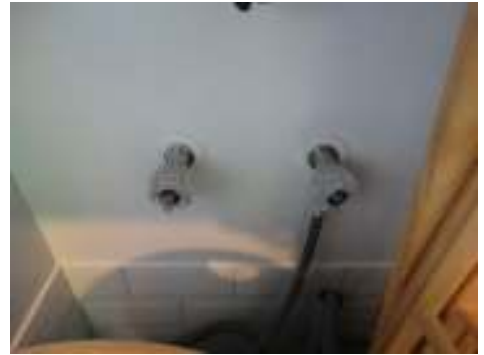
- The washer drains internally to its own plumbing.
- No signs of leakage at the washer hose bib connections.
- The laundry tub and cabinet are in an acceptable condition.
- No visible signs of leakage from the taps or waste trap.

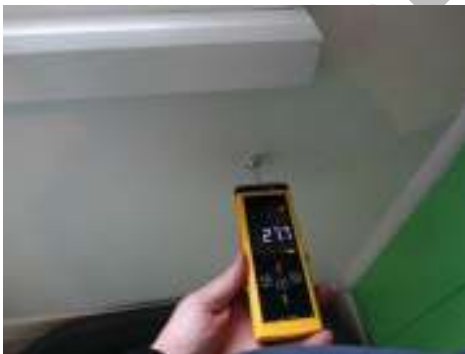
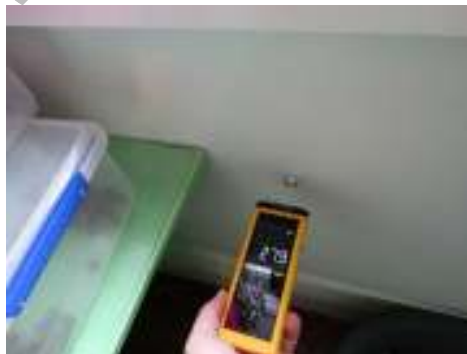
A number of moisture readings were taken within this room all found to be of an acceptable level.

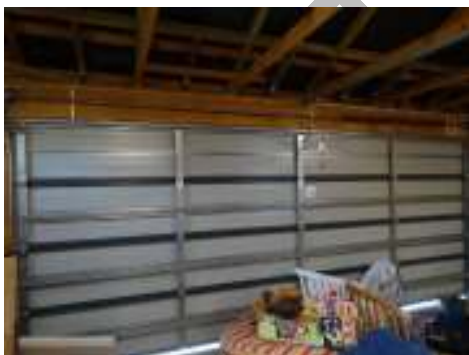
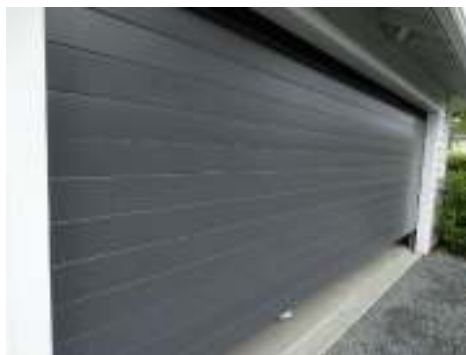
Satisfactory condition.

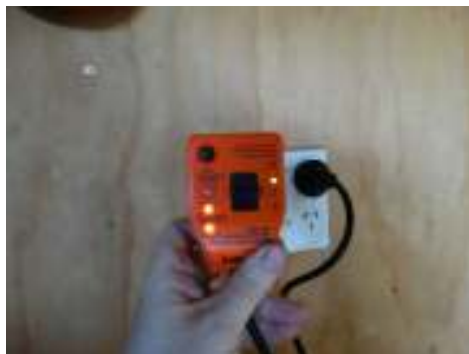
- The lights & switches were functional.
- Accessible power sockets were function.
- Over all the walls & coverings were visually in good condition.
- The flooring is in an acceptable condition.

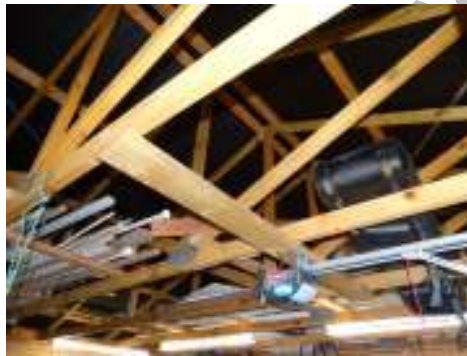
- Sarking is present covering the underside of this roof covering. Sarking is a vapour barrier to reduce the transmission of moisture into the home.
- No signs of excess moisture was visibly showing in the roof space.
- The roof framing looks satisfactory in nature.
- No evidence of pest or insect infestation.
- No rot evident at the time of inspection.
